CRASHWORTHINESS ANALYSIS OF THREE PROTOTYPE AMBULANCE VEHICLES

Raphael Grzebieta
Monash University
Australia
Paper Number 07-0249

ABSTRACT

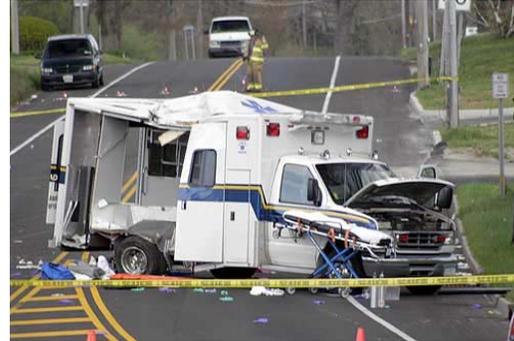
Figure 1a. and 1b. Examples of real world crash outcomes for the rear passenger compartment (EMS Network)

complete disruption of the rear compartment ‘box’ in the type Y and Z vehicles (Figs 1a and 1b) , and some disruption of the vehicle compartment integrity related to the aftermarket modifications to the roof of the vehicle of the type X style.

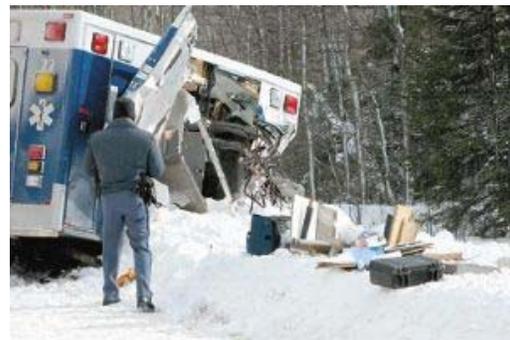
Figure 1b. Image of the ambulance’s right side (EMS Network)

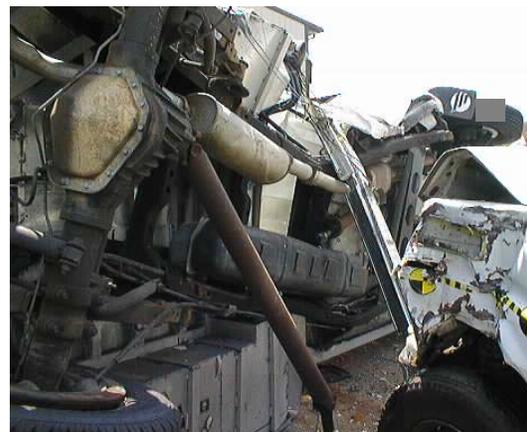
Figure 2a. and 2b. An example of crash test outcome at 44 miles/hr closing speed for a chassis/box configuration. Figure 2a. Immediately after impact, chassis/box ambulance on its side.

Published crash test data confirmed these findings for both frontal and side impacts (Figs 2a and 2b.).

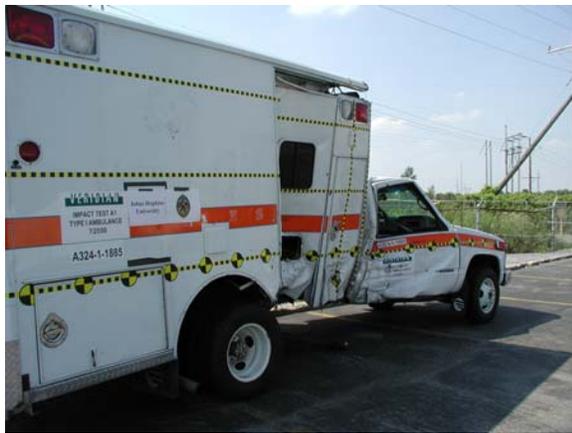
Figure 2 b. The struck vehicle has been righted to demonstrate the intrusion to the rear passenger compartment. (crash and impact test photos provided by the author)

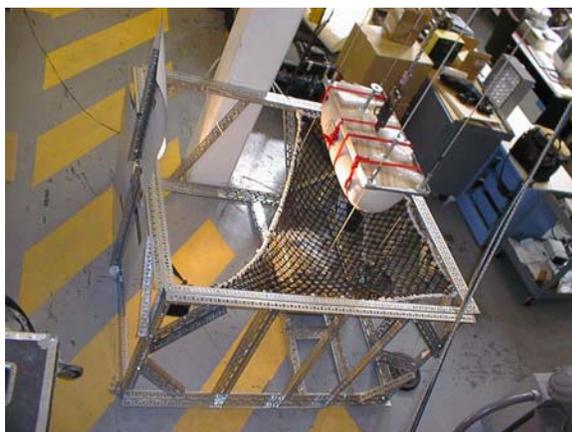
Figure 3. Dynamic testing of a netting device, by Project SUPPORT design team and the Author

Additionally, there was liberal use of netting in a these vehicles – even though no testing of the nature of the netting material or its performance under impact conditions was referenced by any manufacturer. In studies conducted by the project SUPPORT team and the author – the characteristics of appropriate netting structure and dynamic impact performance has been evaluated, as well as an optimal design to allow for adequate human factors issues. (Fig 3.)

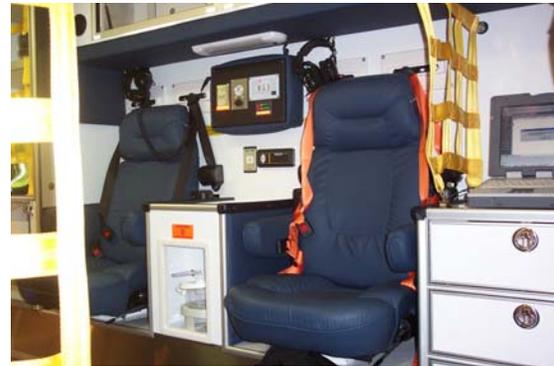
Figure 4. Interior cabinetry and seating design

5. Rear compartment interior design features, (Fig. 4) particularly in and around the seating positions, where there were cabinetry and rigid structures that were potential hazards to seated occupants, and arm rests where there were potential hazards of a side facing occupant being struck in the liver or spleen region in a frontal impact.
